BBC SAFETY ALERT

Date: 1st December 2022

Category: Electrical safety

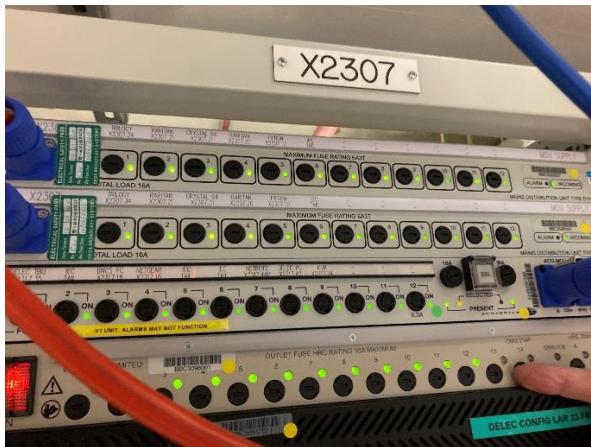
This Safety Alert refers to a reported Safety-Hub incident, where a mains shock was received changing a fuse in a Bryant Mains Distribution Unit (bottom MDU unit in picture).

please ensure that your engineers are aware of this alert and that they are taking all necessary precautions when swapping fuses in panel mount fuse holders. Standard safe practice is to depower any equipment before replacing the fuse. A Risk Assessment RIS-58012 covers fuse replacement in MDUs, which can be referred to for information.

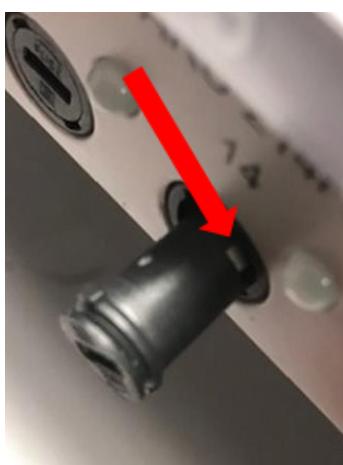
Investigations have shown that the fuse holder can potentially connect with the mains before it is fully inserted, exposing live mains outside the device. In the photo below the arrowed metal tang could become live as the fuse is inserted to around this depth. This issue appears to affect some Bryant MDU's but could be an issue with other MDU's which utilise this type of fuse holder.
